Assessing remediation works in a severely degraded reach of Umbango Creek, New South Wales

A.L. Wilson, R.J. Watts and K.J. Page

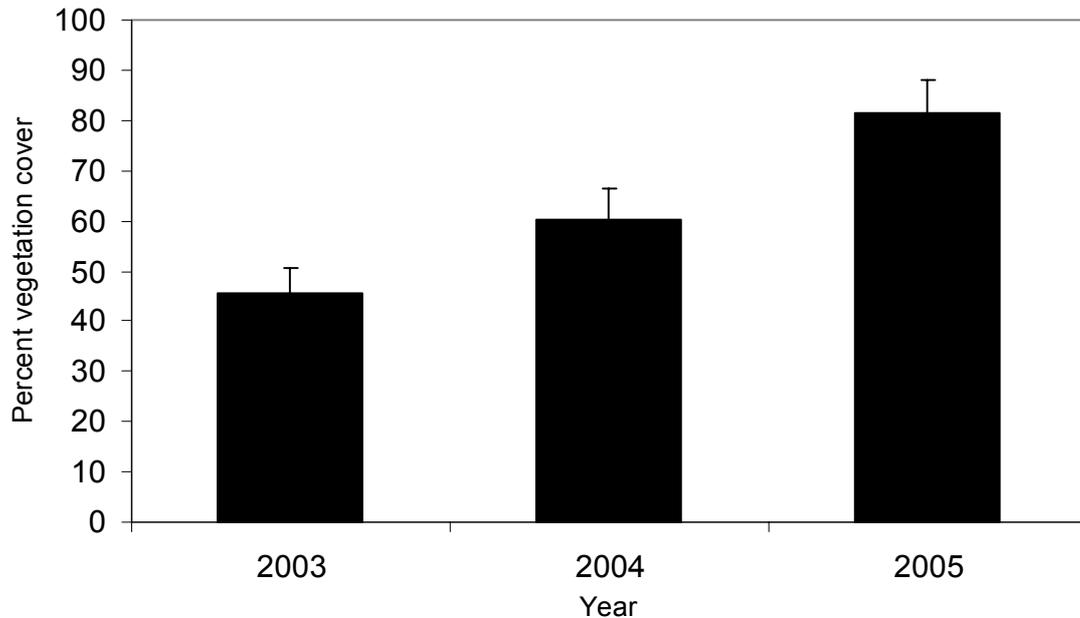
Comparison of percent vegetation cover data showed a significant increase between the first survey in 2003 and the latest in 2005 (ANOVA; $P < 0.05$; Figure 1). This increase occurred despite the drought conditions existing across the catchment and the reintroduction of cattle into the remediated area for crash grazing on a number of occasions. The use of intermittent crash grazing was necessary as feed for livestock became increasingly scarce during the drought.

Figure 1. Average percent cover of vegetation along transects ($n=3$) surveyed within Umbango Creek in 2003, 2004 and 2005; only 2003 and 2005 were significantly different from each other (ANOVA; $P<0.05$).

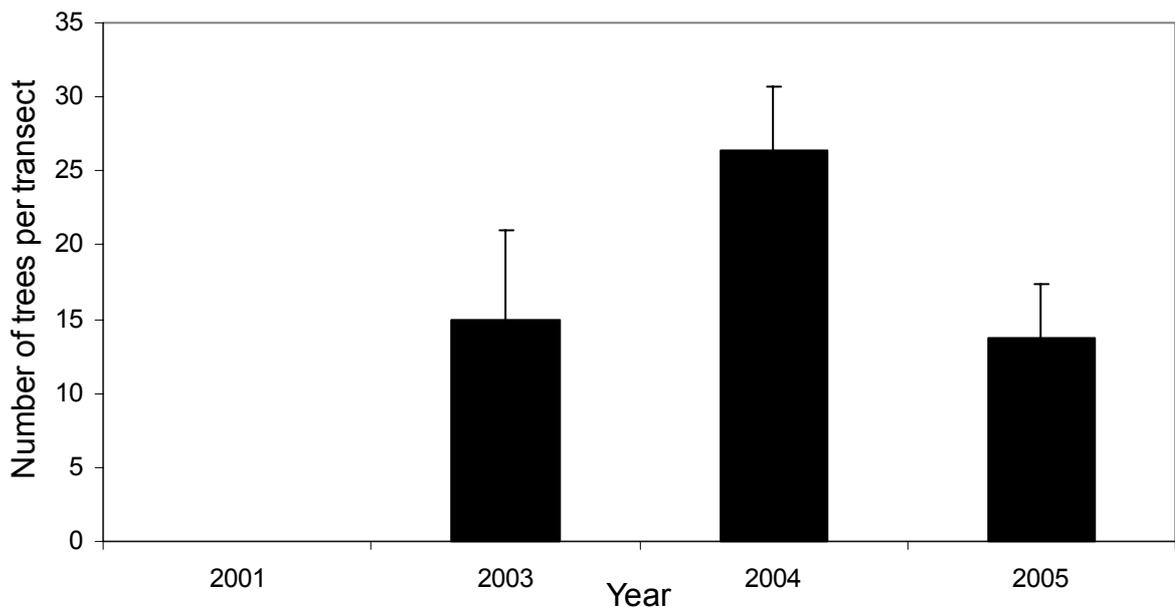
The average number of trees and shrubs counted along the three sample transects within the remediated creek significantly increased between 2001 and 2004 (ANOVA; $P<0.05$, Figure 2) as a result of revegetation work and natural regeneration. The assessments of grazing damage inflicted on trees demonstrated substantial impacts in 2003 and 2004, where 77% and 64% of trees respectively were recorded as having severe damage. In contrast, the number of trees with severe grazing damage recorded in 2005 was only 7%. Despite these observed areas of damage, no significant difference in tree abundance was detected between 2004 and 2005. These data indicate that many of the trees within the study area were able to recover from the impacts of cattle grazing, and that few were actually destroyed as a result of crash grazing.

Figure 2. Average number of trees and shrubs per transect ($n=3$) within Umbango Creek in 2001, 2003, 2004 and 2005; only 2001 and 2004 were significantly different from each other (ANOVA; $P<0.05$).

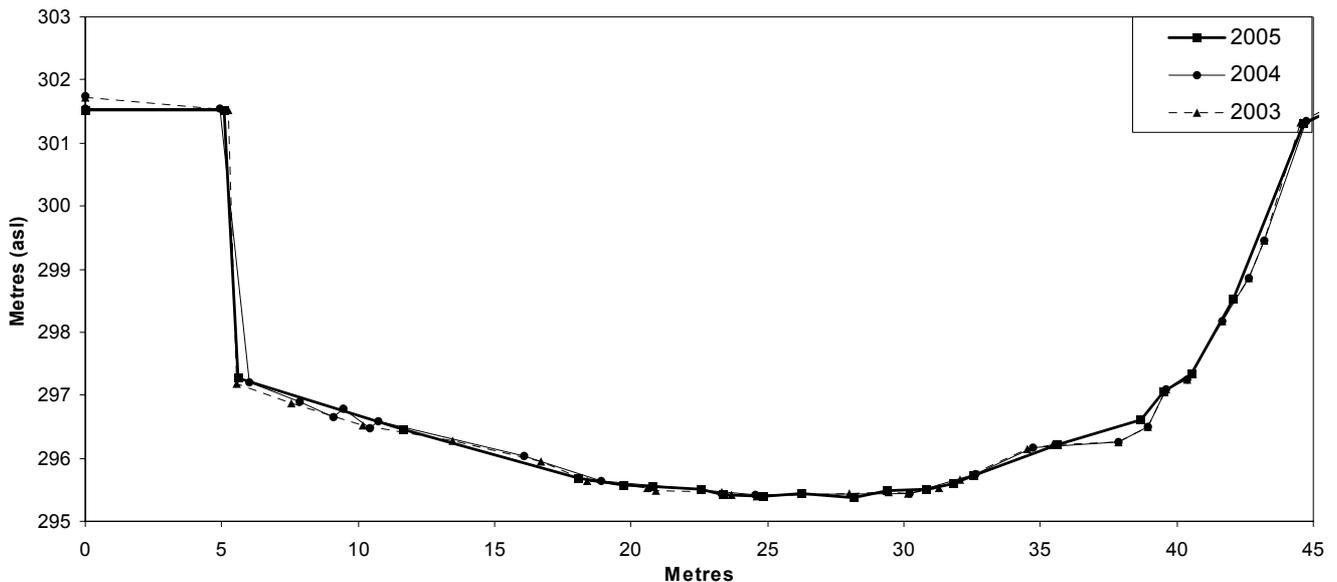
Channel cross sections surveyed at the three reaches of Umbango Creek indicated that relatively little change to channel morphology had occurred during the study period (Figure 3, Figure 4). This channel stability was the anticipated outcome of generally low flow conditions throughout 2003 and 2004 when the creek experienced relatively low discharge conditions with flow velocities below those required to entrain cobbles. Minor river freshes, which occurred in August 2003 and September 2004 following widespread rainfall in the catchment, provided an opportunity to examine the stability of the revegetated channel earthworks.

Figure 3. Channel cross sections at log groyne reach in Umbango Creek surveyed in 2003, 2004 and 2005.

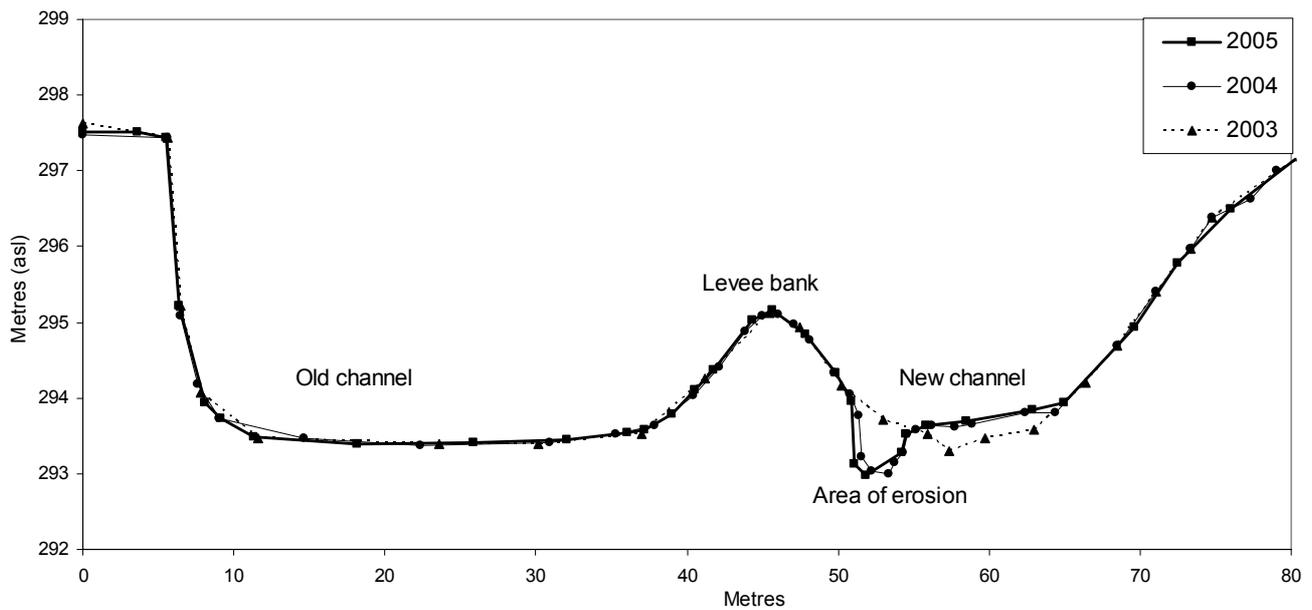
Changes to channel morphology as a result of minor flood pulses were evident only at the levee bank reach where minor bank erosion and thalweg deepening occurred at the levee bank, which was created to short-circuit the previous large bend (Figure 4). Although continuous monitoring of creek discharge was not undertaken at the remediated reach, a nearby permanent gauging station was used to examine the peaks of flow experienced in the catchment (DIPNR <http://www.dlwc.nsw.gov.au/index1.html>). Flow data obtained from the Borambola gauge indicated that the two elevated flow events experienced at the study site were probably relatively small, being approximately 40% of the size of peak flows recorded in 1998 and 2000.

Despite their small magnitude, it is obvious from Figure 4 that some erosion of the levee bank occurred at the bend axis after the rains in August 2003. However, the lack of a significant change in channel morphology between the 2004 and 2005 surveys suggests that the 2004 flow (of similar magnitude) had minimal further erosive impact on the levee bank. This may indicate an increase in bank strength resulting from enhanced vegetation cover (Hickin, 1984). Bend shortening at this reach has increased local channel slope and potential bed shear. The vulnerability of the constructed levee bank to future bend erosion presents a challenge to the on-going success of remediation work in this reach and therefore requires periodic monitoring.

Figure 4. Channel cross sections at levee bank reach in Umbango Creek surveyed in 2003, 2004 and 2005.
