# DAM CONSTRUCTION FLAWS AND THE RECEDING LAKE VICTORIA - UGANDA

**Apunyo Robert**  
**Makerere Institute of Social Research, Makerere University**  
**Kampala, Uganda**  
**P.O Box 16022 Kampala**  
**Email: [rapuny@yahoo.co.uk](mailto:rapuny@yahoo.co.uk)**  
**Tel: +256-712-855013**

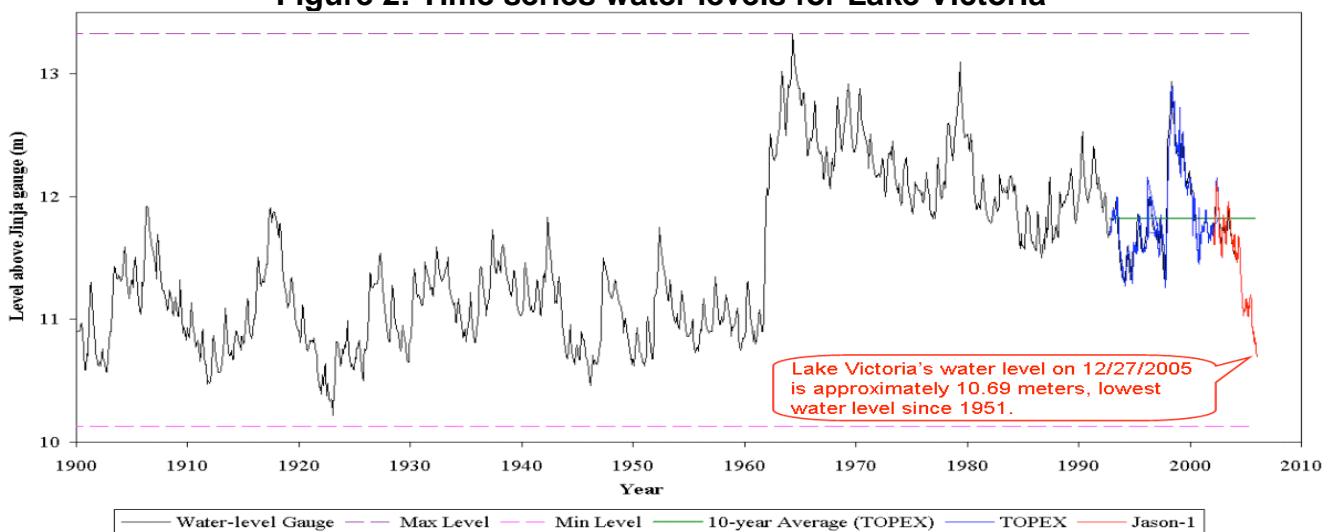
**Figure 2: Time series water levels for Lake Victoria**

The design decision was based on the higher flows of 1965-1998, neglecting the lower pre 1961 flow shown in Figure 2. The contractor assumed that it was more likely that the higher post 1965 inflow pattern would continue as opposed to a reversion to the pre 1960 low flows. The dam contractors also seem to have not factored in the likely impact of climate change in their cost benefit analysis, yet at the inception of this project in the early 1990s; the climate change problem was already a global concern.

Data Source:  
 Historical water level gauge data from Jinja, Uganda (near Lake Victoria's outlet).  
 Satellite radar altimeter data from USDS/NASA/UMD at:  
[http://www.pecad.fas.usda.gov/cropexplorer/global\\_reservoir/](http://www.pecad.fas.usda.gov/cropexplorer/global_reservoir/)

The fact that lakes and rivers are susceptible to some hydrological cycles, demands that the longest time series hydrologic data of lake Victoria should have been used for hydrologic statistical analysis for the design of Kiira dam extension. "As the number of samples grows, the accuracy typically improves" (Maidment, 1993).

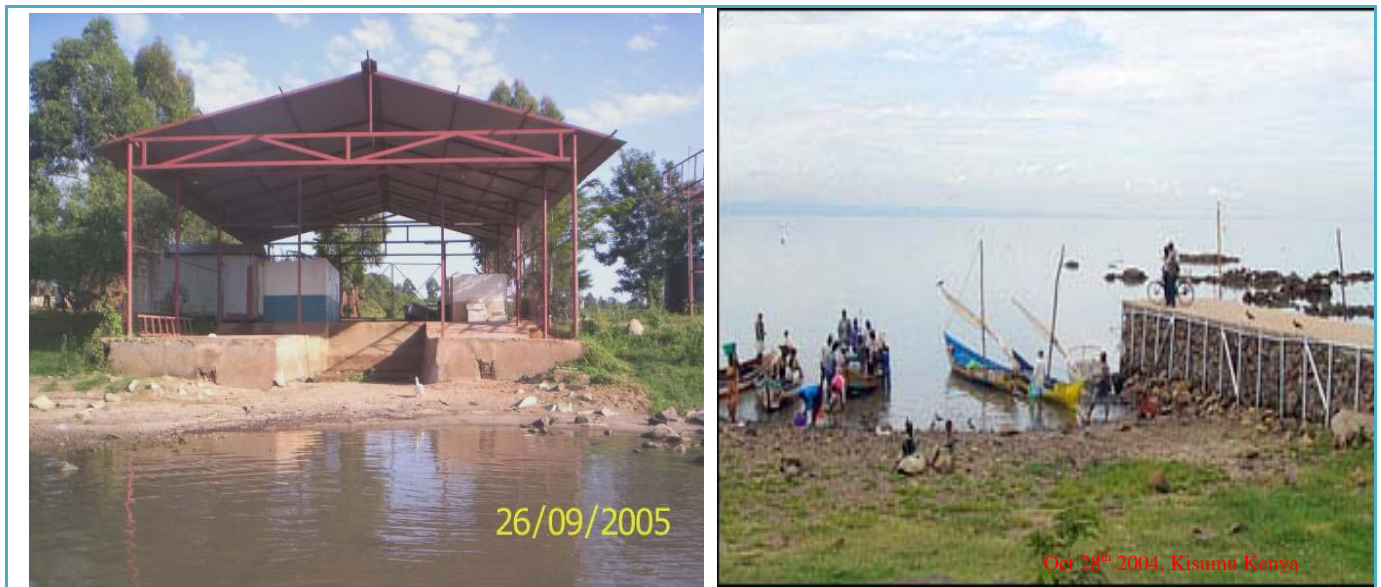
**Figure 4(a):** Majanji fish landing site, Uganda left on dry land due to lowering of lake level.

Fisher folks who used to land their fish catch on the shorelines now dock in the lake. Figure 4 (a) and (b) shows less useful fish landing structures constructed to ensure good fish quality. This has increased the cost of production and undermined income of fisher folks (Lake Victoria Basin Commission, 2006).

Transportation has been affected as vessels can no longer dock at ports due to shallow waters as shown in Figure 4 (a).

**Figure 4(b)** Disrupted shoreline infrastructure like this small dock. (Photograph courtesy USDA Foreign Agricultural Service.); <http://www.fas.usda.gov/>

Docking facilities at Jinja, Mwanza and Port Bell require expensive modifications in order to continue to use them. These costs affect national budgeting and divert resources away from social expenditure. Similarly expensive plans are being prepared to extend water intake works at Kampala, Jinja and Kisumu.

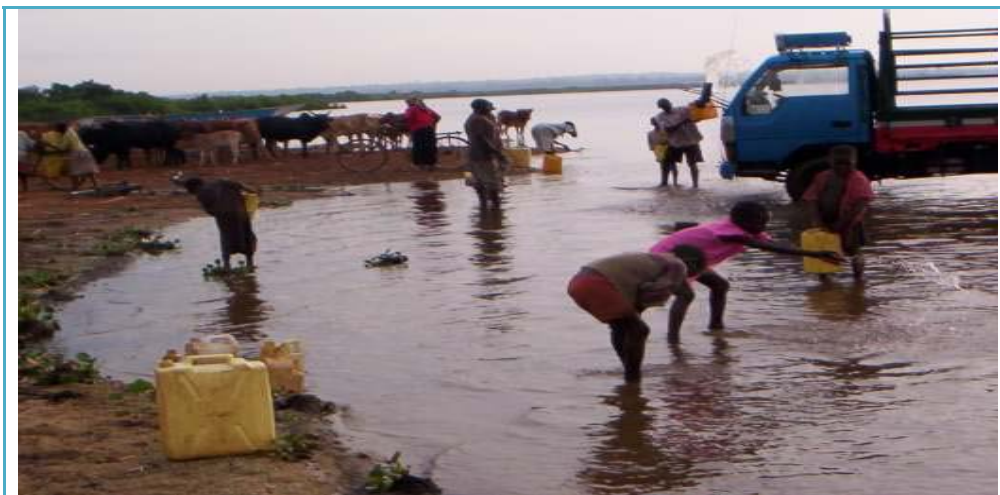
**Figure 5:** Conflicting uses facilitated by shallow shorelines as a result of low lake levels. (Lake Victoria Basin Commission 2006); [www.eac.int/lvdp/lake\\_victoria\\_waterlevels\\_apr\\_06.pdf](http://www.eac.int/lvdp/lake_victoria_waterlevels_apr_06.pdf)

The decline in water levels has altered the natural zonation. The three zones namely; shoreline, littoral and pelagic areas are each meant to support a particular type of biodiversity and human activities. The most productive fish breeding areas have thus been exposed to various conflicting activities shown in Figure 5. These activities range from collection of water for domestic purposes, livestock watering to car washing, thus lowering the quality of water at the shorelines.
