# **Saving Water in Sydney**

**Reid Butler**

*BMT WBM Water and Environment Sydney*

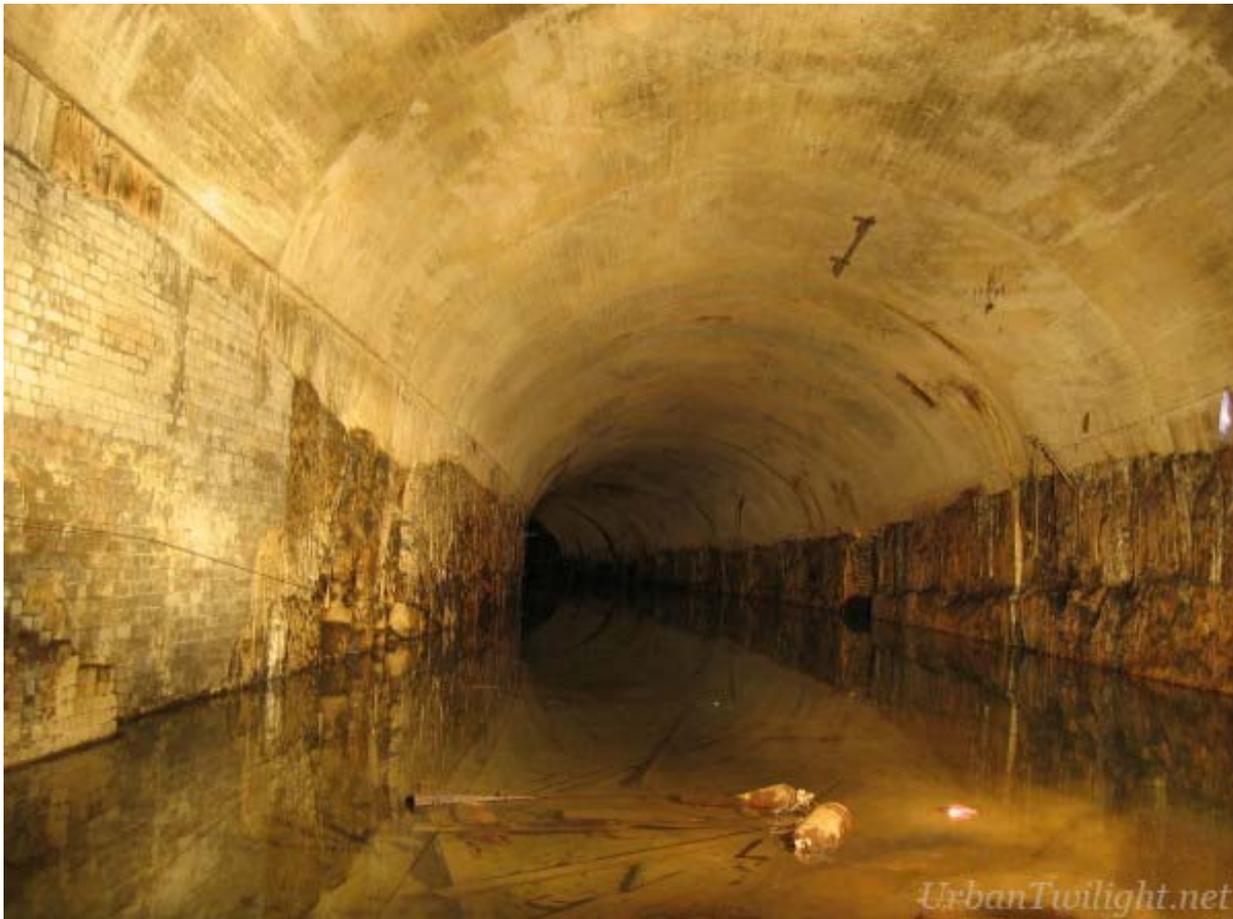
Survey information of the tunnel was old and unreliable so a new survey of the tunnel was conducted. This included water quality monitoring, level surveying and checking the stability of the tunnel wall. Figure 3 shows the tunnel, looking to the north.

**Figure 5: The disused railway tunnel**

The tunnel was constructed in a cut and fill method, with formwork built and concrete poured to create the roof. This allows water to seep in through the sandstone on the sides. The reason the tunnel was not used for railway lines was it began filling with water from a spring during construction. This inflow continues today.

The survey and assessment of groundwater seepage found that the current available volume in the tunnel was 500kL. The wall survey found it structurally sound to handle increasing water levels with some sealing and this was proposed to create increased available volume.

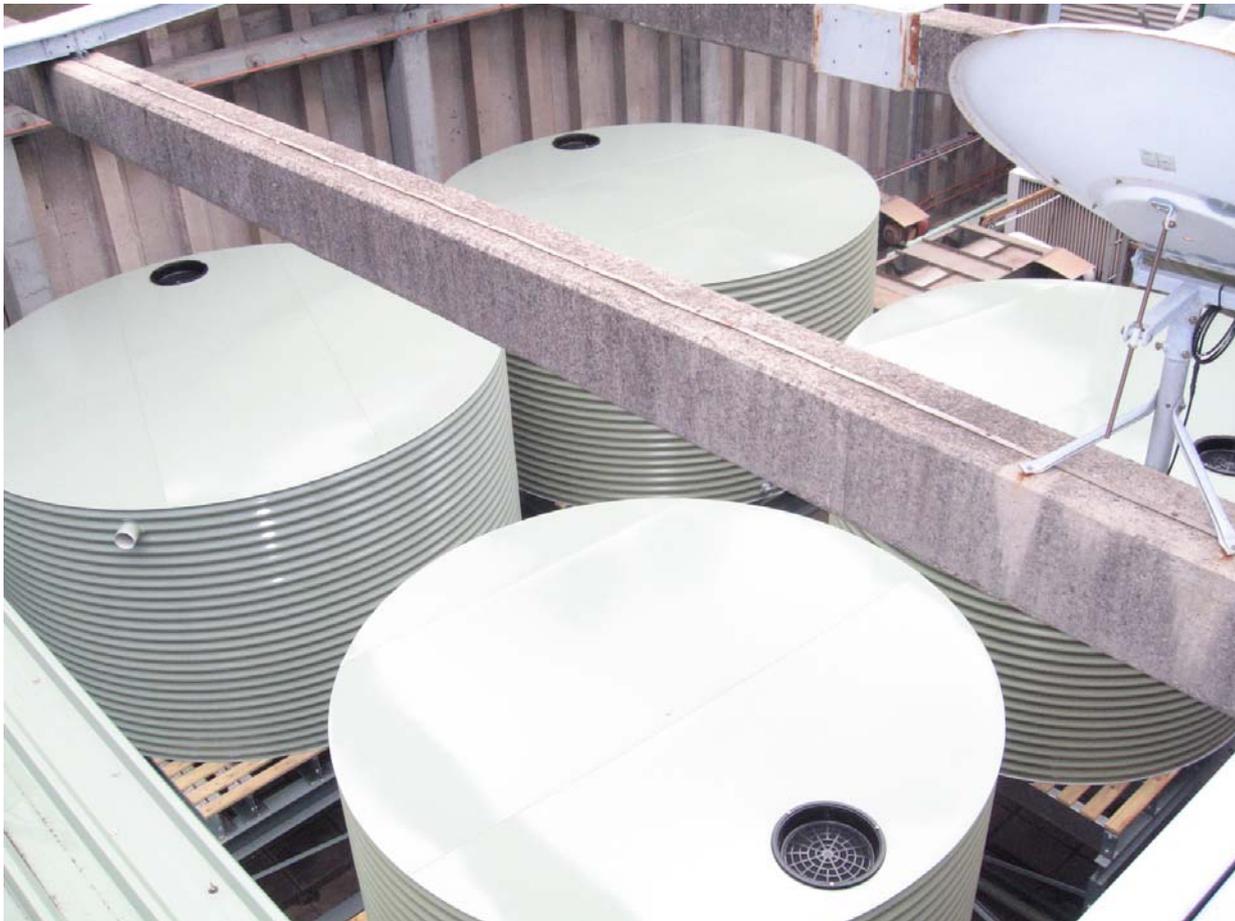
Four tanks (2x10kL and 2x20kL) were installed on the roof next to the main cooling tower (Figure 4). Two new pumps were installed in the sump to ensure adequate pumping to avoid flooding a 100 micron filter was put on the outlet of the pumps. A 50mm line was run through a service void to take the water to the roof tanks. The 150mm downpipe from the office roof to the street stormwater system was cut into and diverted to a conveniently adjacent downpipe leading to the sump.

**Figure 6: Storage tanks on the roof**

Meters were installed throughout the system to monitor performance in the first months of operation which has revealed some issues with the system. Pumps are activated by float switches in the sump and the tanks on the roof responding to the demand of the cooling towers. The levels the float are set at are causing the pumps to operate in short bursts to meet demand throughout the day rather than one long session to fill the tanks overnight which would be preferable using off peak power.
